DELAWARE RIVER BASIN  
OLD MILL STREAM  
NEW CASTLE COUNTY  
DELAWARE

# HOOPES DAM DE 00015

## PHASE 1 INSPECTION REPORT NATIONAL DAM SAFETY PROGRAM.

Based upon visual observations and review of the information obtained from the City of Wilmington, Water Division, Edgar M. Hoopes Dam is considered to be in overall fair condition.

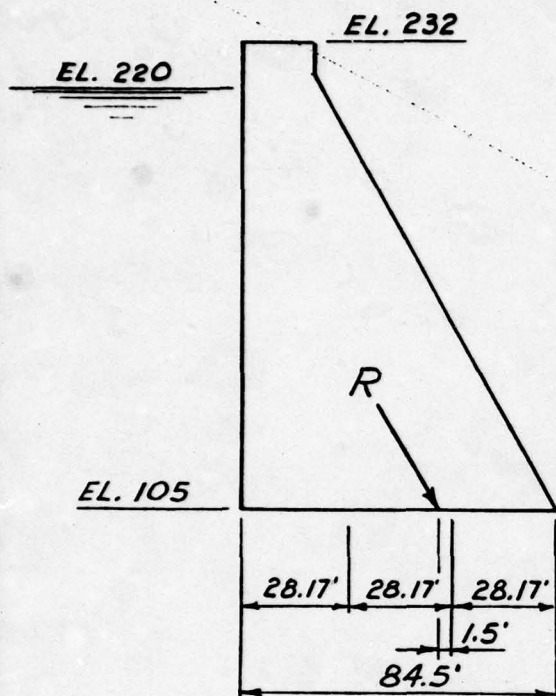
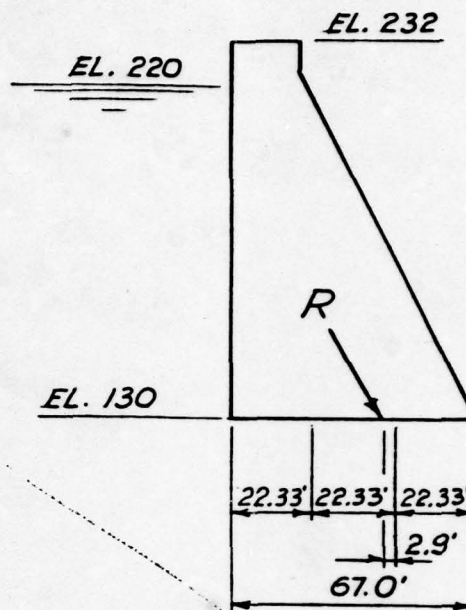
PLATE 4

f. Evaluation. Stability analyses of the dam (performed by O'Brien & Gere Engineers, Inc.) indicate that the foundation reaction is not in the middle third of the base for loading conditions imposed by the PMF event. The dam is stable under normal loading conditions and would be stable for up to a 100 year statistical flood loading condition (National Weather Service, TP #40, 6 hr., 100 yr. rainfall). The results of the stability analyses are presented on Plates 4 through 7 of Appendix E.

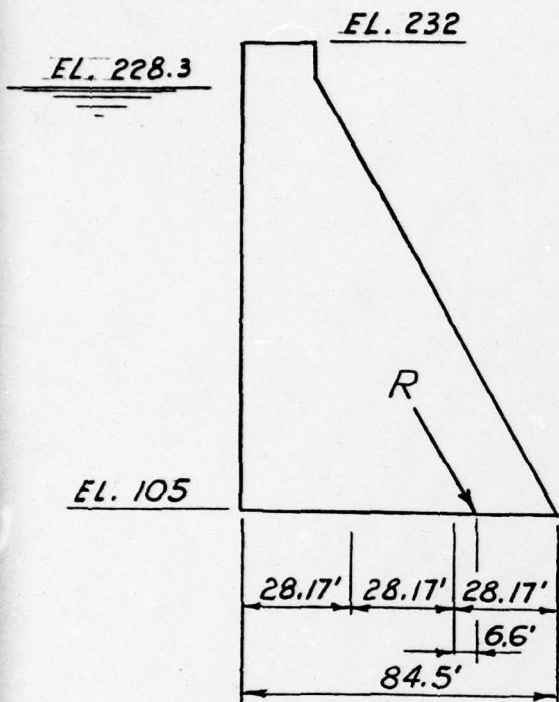
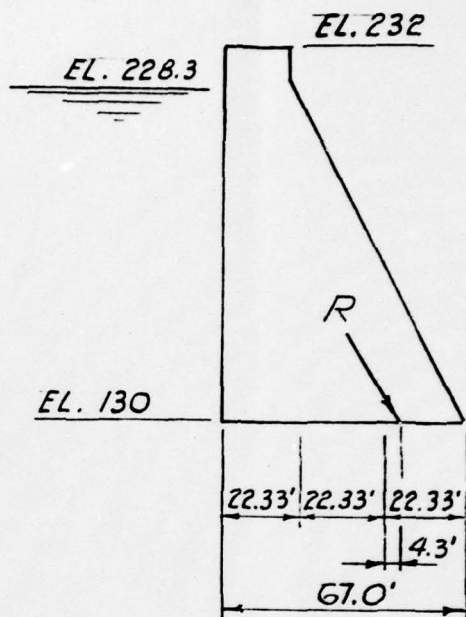
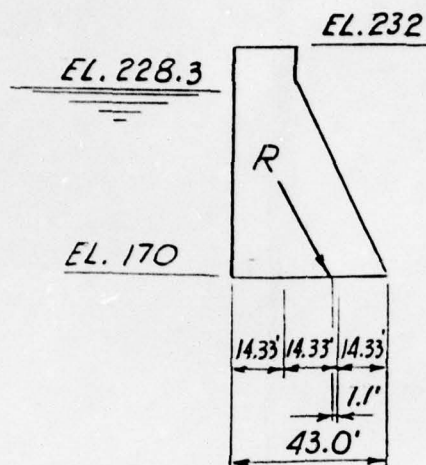
PLATE 7

a. While the spillway is adequate to pass the Probable Maximum Flood without overtopping, the dam has been determined to be unstable for loading conditions imposed by the PMF. Post-tensioning of the dam to provide adequate stability during the PMF was being performed at the time of the inspection.
